750 #4
Rev. 9/22/69

SERVICE BULLETIN

AMERICAN HONDA MOTOR CO., INC. MOTORCYCLE SERVICE DEPARTMENT

DRIVE SPROCKET RECALL

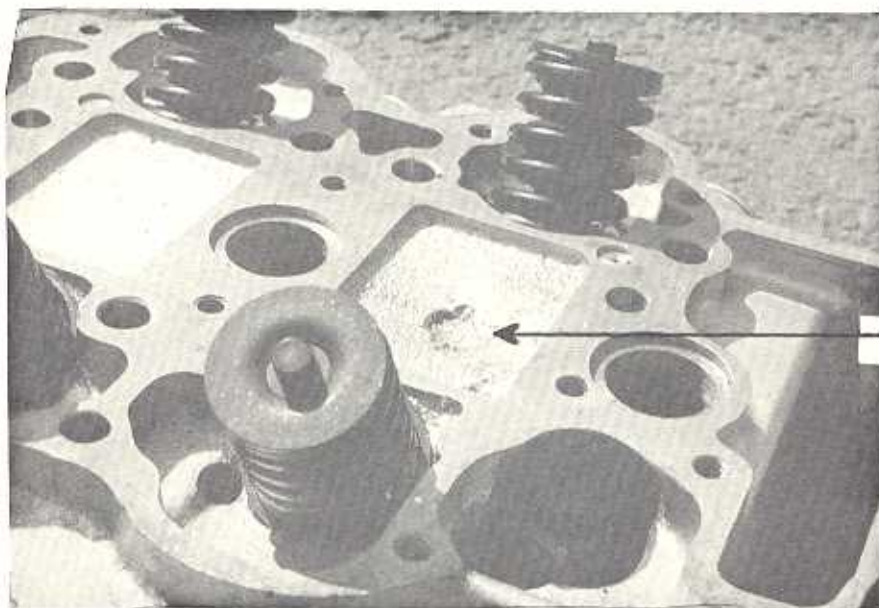
CYLINDER HEAD DAMAGE CAUSED BY TACHOMETER GEAR STOPPER BOLT

The tachometer gear, driven by the gear on the camshaft, is held in place by the tachometer gear stopper bolt. Occasionally a stopper bolt becomes loose. If the stopper bolt falls out, the cam lobe may push it through the upper section of the cylinder head.

To safeguard against possible engine damage, the stopper bolt should be secured whenever the cylinder head cover is removed. Because the position of the bolt in the head cover makes tab-type lock washers ineffectual, a bonding-type fastener sealant should be used. This sealant will form a bond between the threads, securing the bolt.

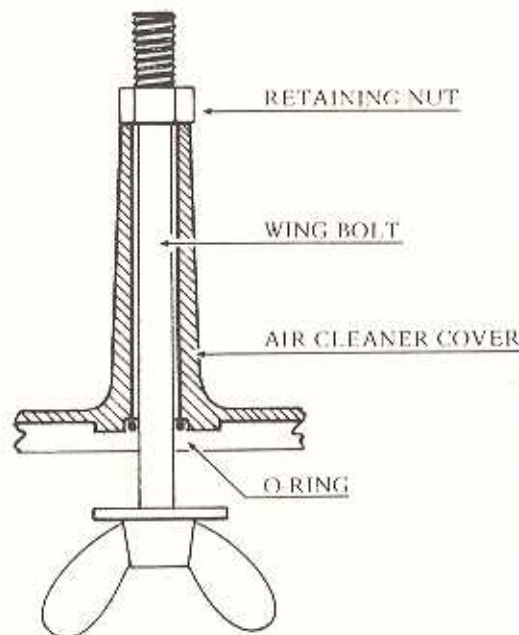
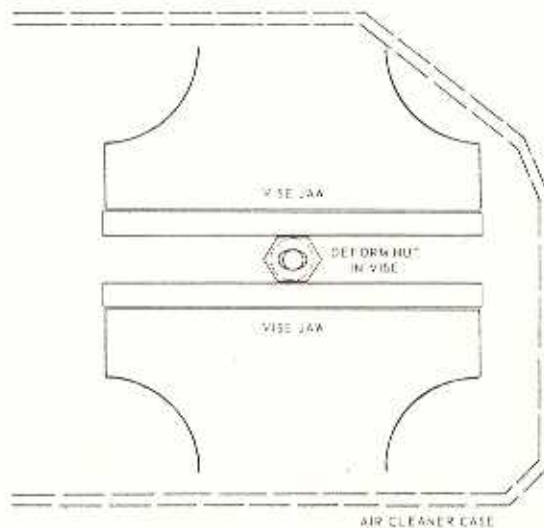
Wing bolts using retaining nuts may loosen from vibration and allow the retaining nuts to drop free. If loose nuts should enter the carburetor connecting tubes, it is possible for them to reach the engine and cause damage to pistons, valves, and cylinder head.

To prevent possible engine damage, the retaining nuts must be secured on the wing bolts. With wing bolts installed in the air cleaner cover, and retaining nuts in place below the threaded section of the wing bolts, distort the retaining nuts by pressing them in a vise. When distorted, the nuts will not pass the threaded section of the wing bolts, and their installation will be secure.

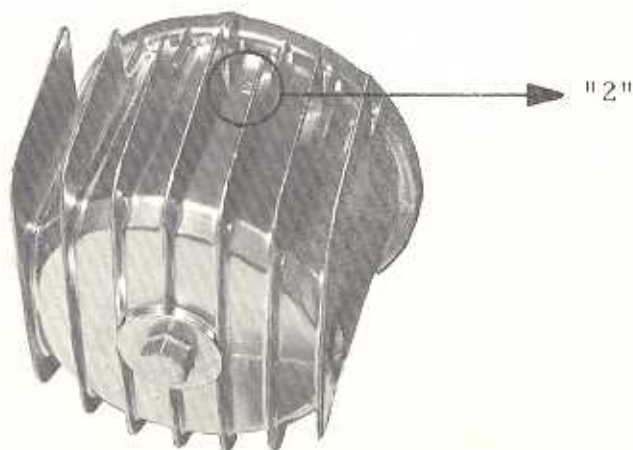
The width across the flats of the oil filter center bolt has been changed from 14mm to 12mm to prevent over-tightening of the oil filter case. All original center bolts should be replaced with the modified center bolt at the earliest opportunity (periodic inspection, oil change, etc.). The fixing torque for the center bolt is 22-24 lb-ft.

The modified oil filter case is provided with 8 ribs radiating from the center bolt boss inside the case. It is stronger and requires less tightening torque to form an oil seal than the original cases. All oil filter cases should be checked for hairline cracks around the center bolt boss when installing the new center bolt. If any cracks exist, replace the oil filter case with a modified case.

The new oil filter case is identified by the numeral "2" stamped on the top surface between the center vanes (see photo).

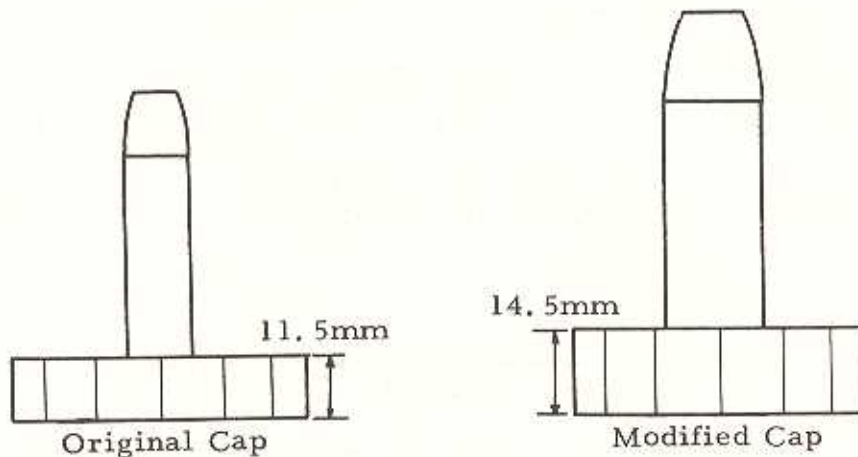
Modified throttle valve and cable kit installation can be identified by visual inspection of the carburetor cap. The modified cap is 3mm taller than the original cap.

Whenever CB-750 motorcycles within the affected serial number range are brought into your shop for service, inspect the carburetor caps to determine whether throttle modification is required, or has previously been performed.

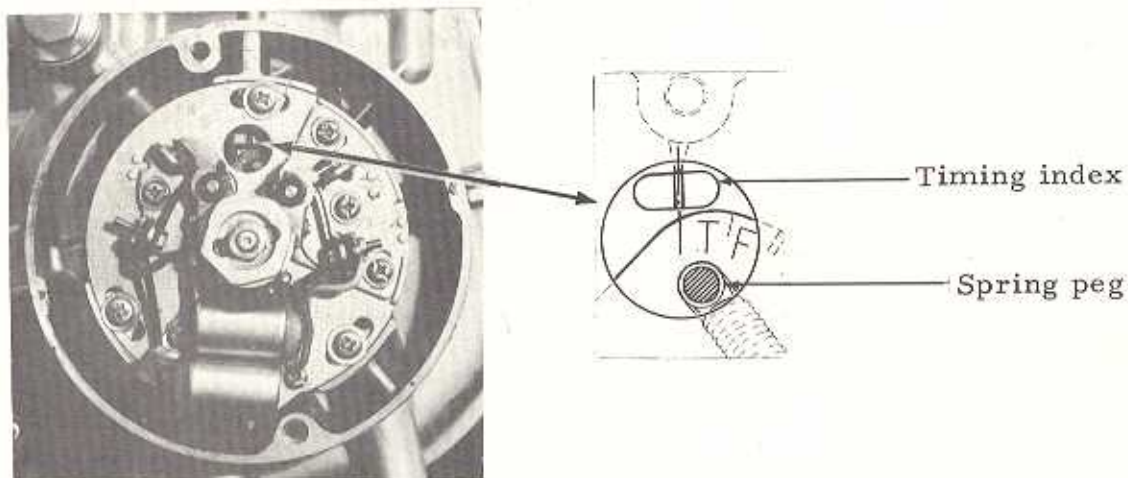
Fig. 1. Point cam position at 15° ATDC.

A loose cam chain can produce a loud clattering noise, similar to that made by loose tappets. It may also affect valve timing, resulting in performance loss.

The CB-750 shop manual does not specify a recommended crankshaft position for adjusting the cam chain tensioner. For effective operation, the tensioner must be adjusted when the crankshaft is rotated to 15° ATDC of cylinders #1 and 4, immediately after cylinder #1 has fired (see Fig. 1).

4. Rotate the crankshaft clockwise until the spring peg on the advancer assembly at the 1.4 position is just to the right of a line from the timing index (see Fig. 1). This position is 15° ATDC 1.4.*
5. Loosen the cam chain tensioner lock nut, and back out the setting screw until the tensioner arm is released and moves in to take up the slack.

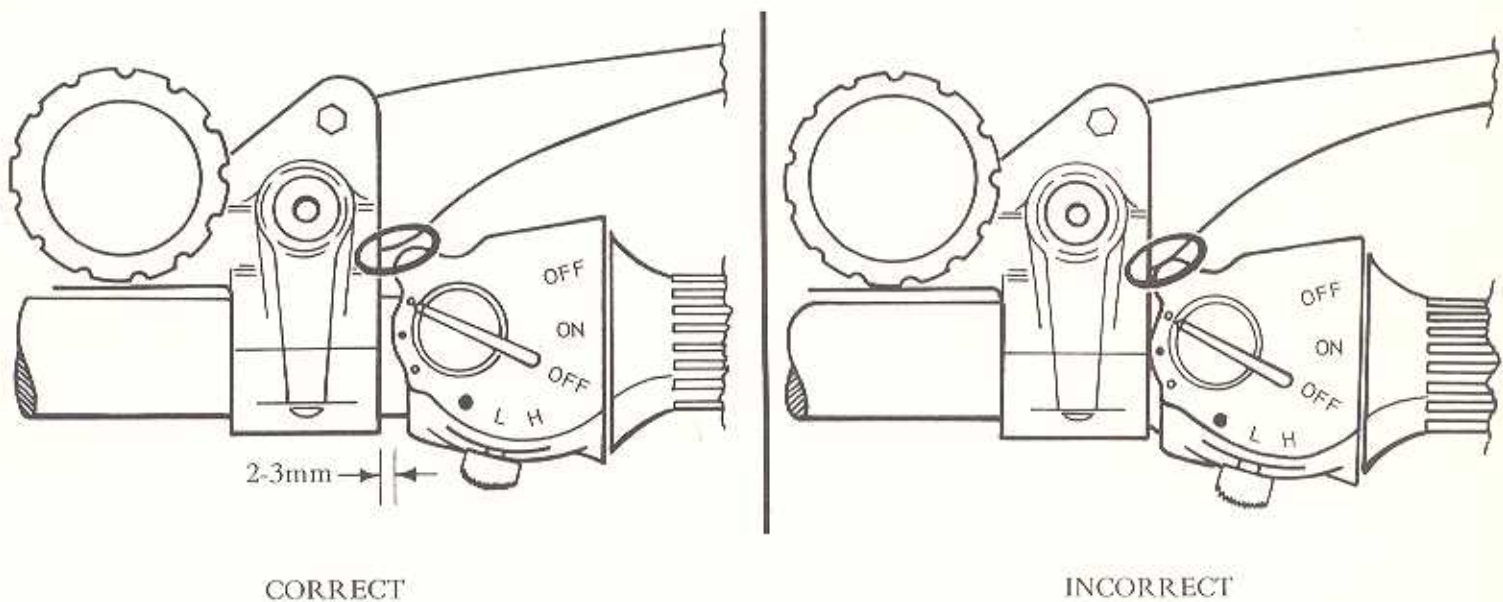
MASTER CYLINDER-LIGHTING
SWITCH ASSEMBLY DETAIL

If the master cylinder is turned or relocated for any reason, make certain that there is at least 2-3mm clearance between the lighting switch assembly and the master cylinder holder (see Illustration). If the brake lever contacts the switch assembly, the front brake will not fully release and rapid brake wear will result.
