750 #4
Rev. 9/22/69

SERVICE BULLETIN

AMERICAN HONDA MOTOR CO., INC. MOTORCYCLE SERVICE DEPARTMENT

DRIVE SPROCKET RECALL

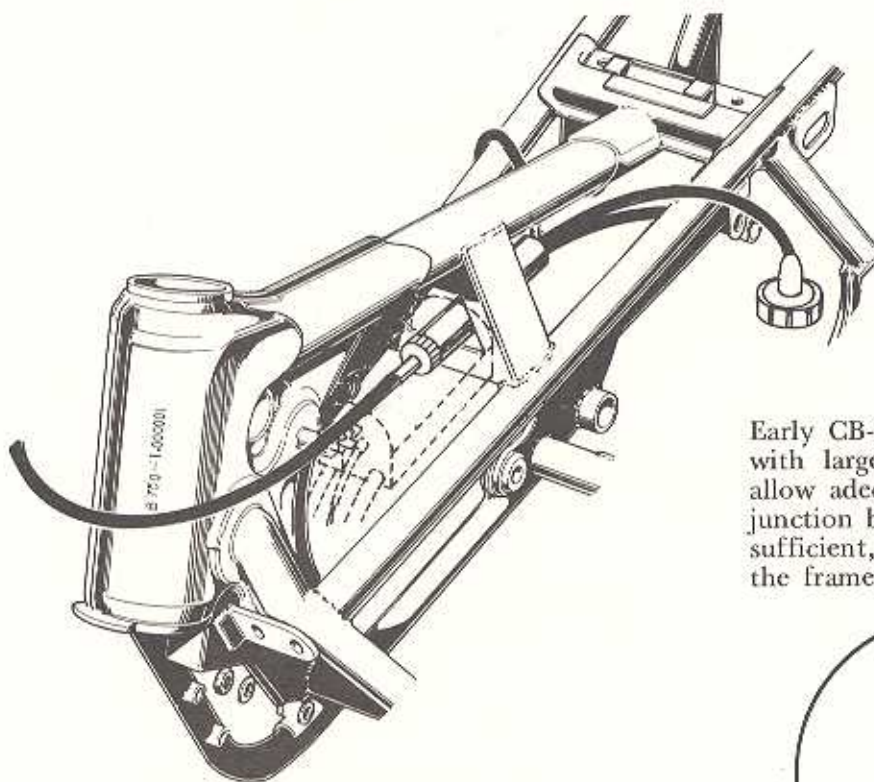
Early CB-750s may be equipped with large coils which will not allow adequate clearance for the junction box. If clearance is insufficient, file a small notch in the frame cross-piece.

1. Turn fuel valve to off position, remove fuel lines from valve, and remove fuel tank.
2. Remove carburetor caps, tops, and throttle valve assemblies.
3. Open right handlebar grip assembly, and remove throttle cable.
4. Remove jet needles and needle keepers from throttle valves. Save needles and keepers for installation in modified throttle valves.
5. Set aside old throttle cable, throttle valves, throttle valve springs, carburetor caps, and carburetor top assemblies. These parts must be identified and stored in accordance with standard procedure for warranty parts disposition.
6. Loosen coil mounting screws, and move the coils as far forward as possible to allow clearance for the larger junction box of the modified cable.
7. Install new throttle cable. Cable must be routed as illustrated below. Incorrect routing will cause improper throttle operation.

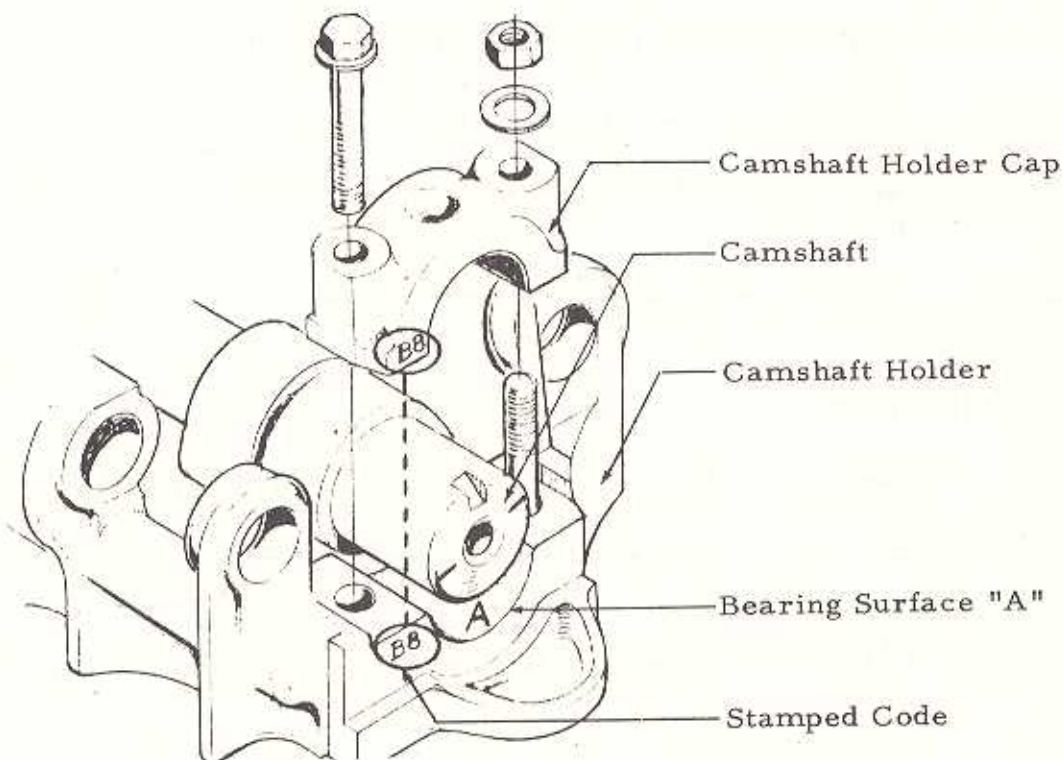
Fig. 1. Camshaft holder and cap showing code stamps.

The camshaft holder and holder caps are now available in matched sets only (see Parts Bulletin #750-10). The new camshaft holder has a stamped code on both sides, usually consisting of a letter and a number. An identical code mark is stamped on one side of the camshaft holder cap.

The camshaft holder caps should be mounted on the camshaft holder so that the code stamp on the holder is adjacent to the matching stamp on the holder cap (see Fig. 1, above).

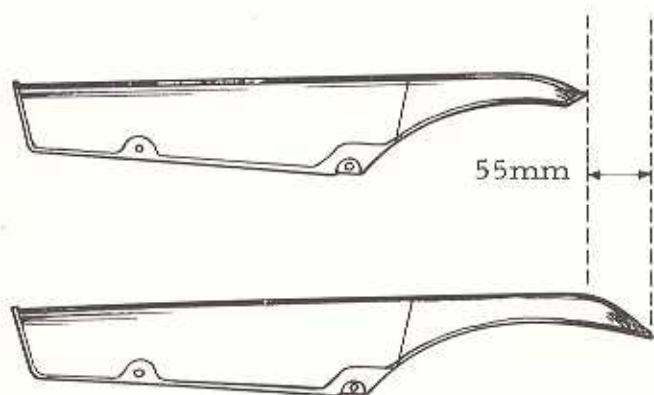
Fig. 1. Modified Chain Cover

To discourage CB-750 owners from turning off the chain oiler, the chain cover has been modified to prevent surplus chain oil from being thrown onto parts of the machine. The modified chain cover is 55mm longer than the original cover, and tapers to a tip to allow any surplus oil to be carried to the rear, away from the wheel and sprocket. The new chain cover is available at no charge to every owner of a CB-750 within the Frame Number range given below, regardless of normal warranty restrictions on mileage, date of purchase, or ownership.

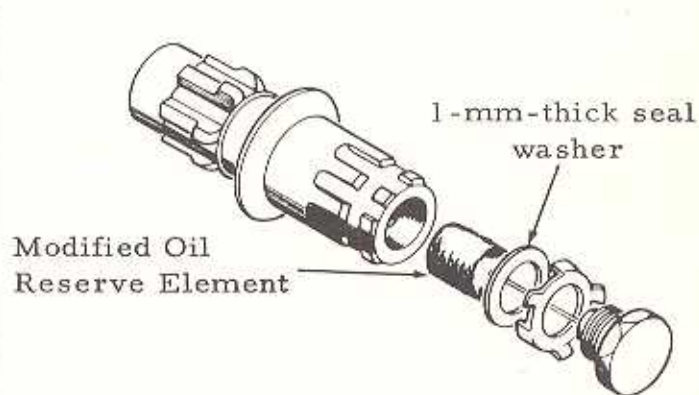
Fig. 2. Chain Oiler and New Parts

In addition, American Honda is also making available a modified chain oiler reserve element and a 1-mm-thick seal washer to provide better control of the oil flow through the final shaft.

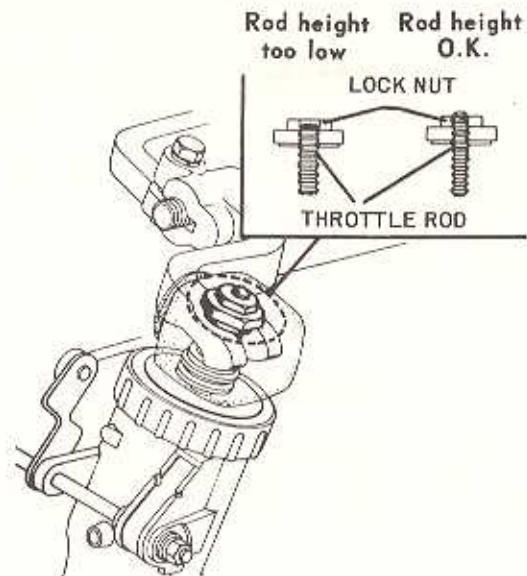
Fig. 5. Throttle Rod Lock Nut

Tightening torque for the lock nut is 10.3-17.3 lb.in. (.86-1.44 lb.ft.). If the lock nut is overtightened or if throttle rod protrusion (Fig. 5) is insufficient, the threads of the throttle rod may strip.

To synchronize the carburetors, adjust the height of the carburetor throttle rods (Fig. 4) so that all four cylinders will show equal vacuum readings. Make sure that all throttle rods extend at least one thread above the lock nuts (Fig. 5).

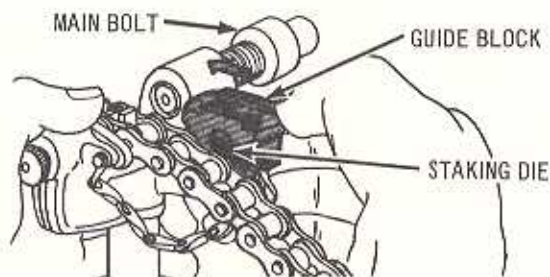
Fig. 11

CAUTION: Less than 3/4 turn will not stake the master link securely. More than 3/4 turn may crack the master link pin.

- 6.a. Reposition the guide block so that the staking die faces the master link pin and the protruding shoulder of the guide block is below the side plates of the drive chain.
- b. Screw the main bolt in until the staking die contacts the master link pin. Check the position of the chain to be certain that the staking die is centered across the master link pin.
- c. Screw the main bolt in an additional 3/4 turn to stake the master link pin.

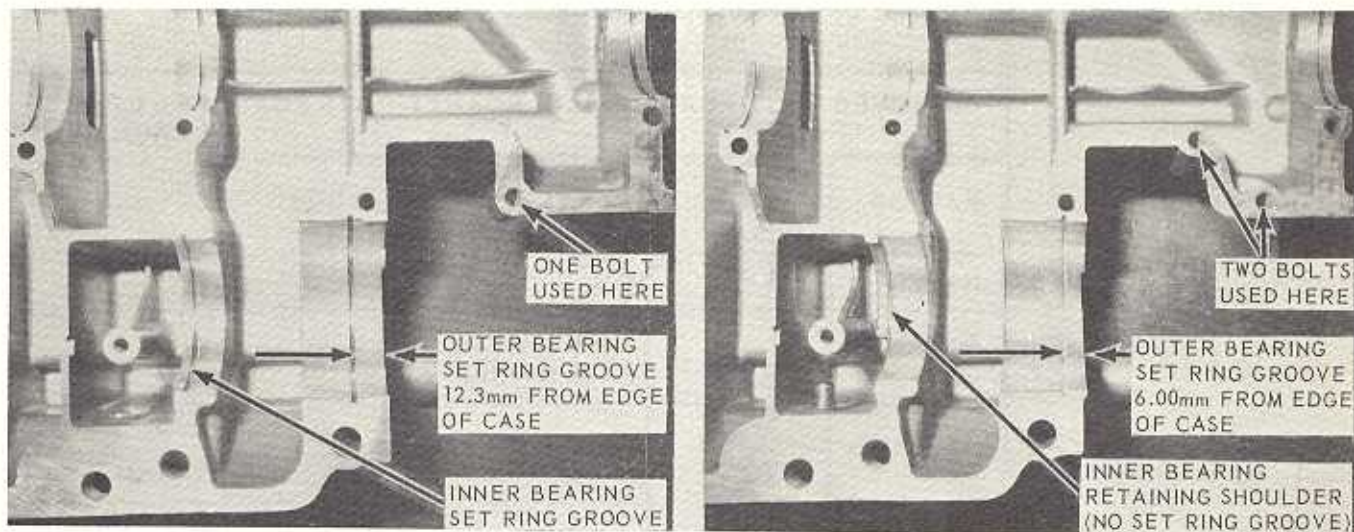
VIEW OF UPPER CASE
crankcase assembly P/N
11010-300-070/080/090

VIEW OF UPPER CASE
crankcase assembly P/N
11010-300-110

Non-interchangeability of old and new crankcases and final drive bearings may require repairs to include the installation of parts not actually involved in the damage (e.g. Final drive bearing failure requires crankcase replacement).

Superseded crankcase assemblies and final drive bearings will no longer be supplied. In CB-750 engines prior to engine number CB750E-1044806, if either the crankcase assembly or final drive bearing becomes damaged or unserviceable, install the replacement crankcase set. Replacement crankcase sets include crankcase assembly P/N 11010-300-110, final drive bearing P/N 96100-63050, and all parts necessary for conversion.

Replacement crankcase sets include crankcase assy. P/N 11010-300-110, final drive bearing P/N 96100-63050, and all parts necessary for conversion.

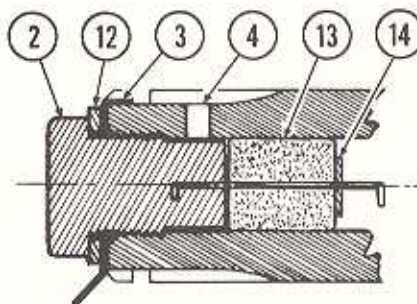
CB-750 engines through number CB750E-1026143 are factory equipped with a drive chain oiler that is adjustable only by replacing shim washers under the final drive shaft plug.

1. Remove left crankcase cover.
2. Open lock washer tab and remove final drive plug.
3. Replace shim washer under final drive plug. Install a thicker washer to increase oil flow, or a thinner washer to decrease oil flow.
4. Reinstall final drive plug. Tighten to 25 ft. lb. torque.
5. Wipe drive chain clean with a rag. Operate the motorcycle at 50-70 m.p.h. for approximately one minute. Inspect drive chain to determine oiler output. Readjust if necessary.
6. When desired oil flow is obtained, fold lock washer tab against plug head, and reinstall left rear crankcase cover.

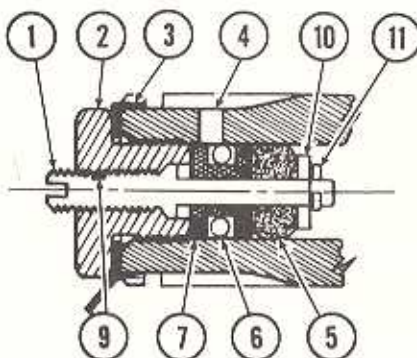
A special replacement drive chain oiler, with adjusting screw, is available for installation on CB-750 engines through number CB750E-1026143.

1. Remove left rear crankcase cover.
2. Remove and discard original drive chain oiler assembly, consisting of:
 - Final drive shaft plug
 - Tab lock washer
 - Shim washer
 - Oil felt
 - Felt setting washer
3. Assemble replacement drive chain oiler. Refer to illustration for parts replacement. Lubricate threads of adjusting screw before inserting the screw in the final drive shaft plug.

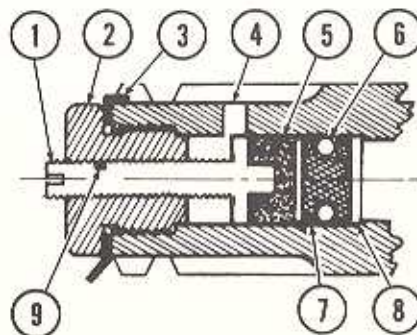
CB750 engines, #CB750-1026144 and subsequent, are factory equipped with a drive chain oiler which has an adjusting screw. This drive chain oiler uses large diameter components which cannot be installed in earlier engines.

NOTE: When a new replacement oiler has been installed, start with adjusting screw in full counterclockwise position (maximum oil flow), test ride to check oil flow, and turn adjusting screw clockwise by small increments until desired oil flow is obtained.

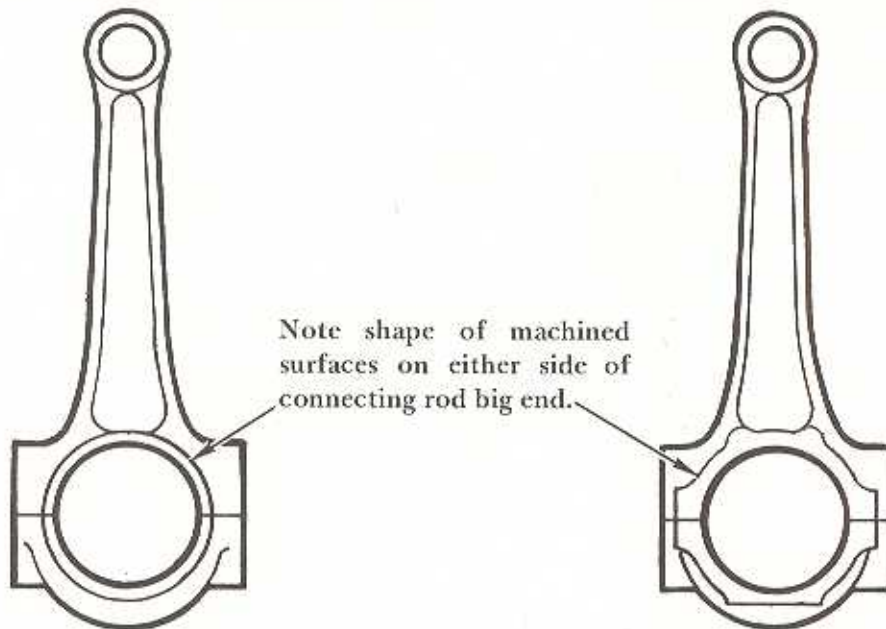
Starting with engine serial number 1017739, CB-750 connecting rods were redesigned to facilitate the manufacturing process. Connecting rods of the early design have been discontinued, and only the redesigned connecting rods are supplied as replacement parts for all CB-750 engines.

EARLY
CONNECTING ROD
Engine #CB750E-1000001
through CB750E-1017738

REDESIGNED
CONNECTING ROD
Engine #CB750E-1017739
and subsequent

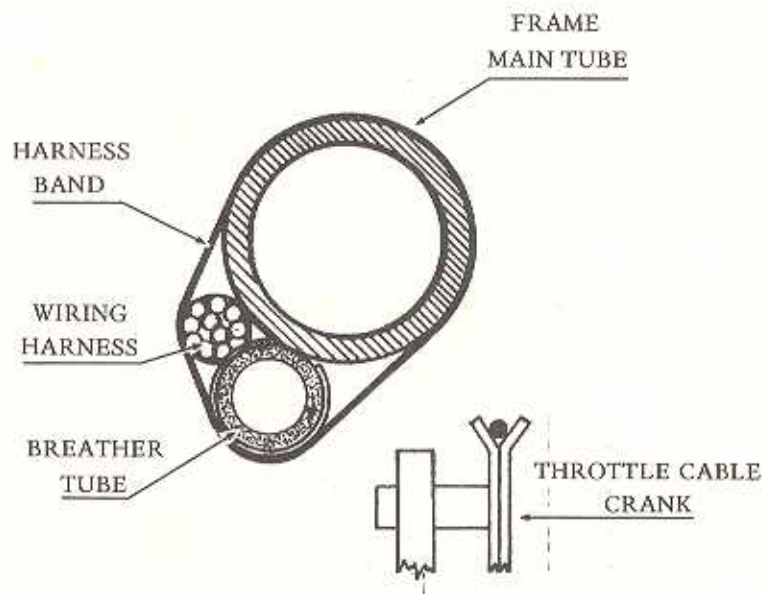
VIEW LOOKING TOWARDS THE REAR

The wiring harness and engine breather tube must be routed to avoid contact with the throttle cable crank above the carburetors.

As delivered from the factory, a harness band holds the wiring harness and breather tube away from the throttle cable crank. If the wiring harness and breather tube are moved during service or repairs, be sure to reinstall them as illustrated below.

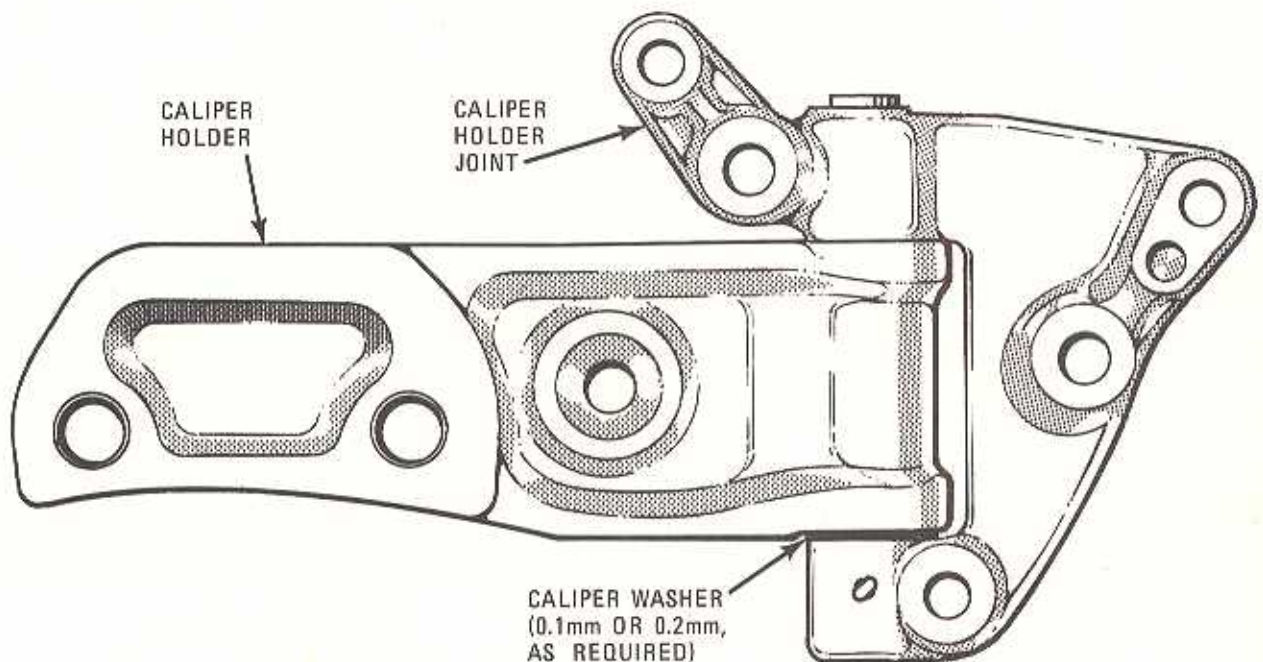
Application of the front wheel disc brake may be accompanied by a distinct "click" or "clunk" type sound that is hard to locate. It has been determined that this noise is caused by excessive clearance between the caliper holder and the caliper holder joint, which permits vertical movement of the caliper holder. This noise does not indicate any condition which would affect braking performance, but the noise may be disturbing to the rider.

Shim washers are available in thicknesses of 0.1mm and 0.2mm for installation between the caliper holder and caliper holder joint, as required.

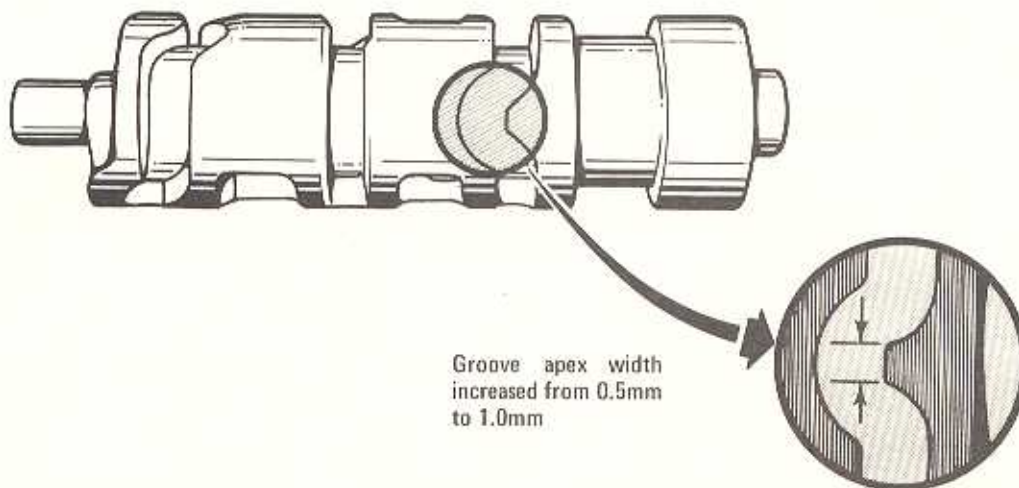
Groove dimensions in the modified shift drum have been altered. The flat apex of each gear change position on the cam groove has been increased from 0.5mm to 1.0mm, as illustrated below.

The modified shift drum has been incorporated in the manufacture of CB-750 transmissions, beginning with engine serial number CB750E-2304501. If any CB-750 with an engine number prior to CB750E-2304501 shows insufficient gear engagement, replace the original shift drum with the modified type.

When repairing any transmission which has exhibited erratic operation be sure to check all other related parts (shift forks and gears) for possible wear or damage.

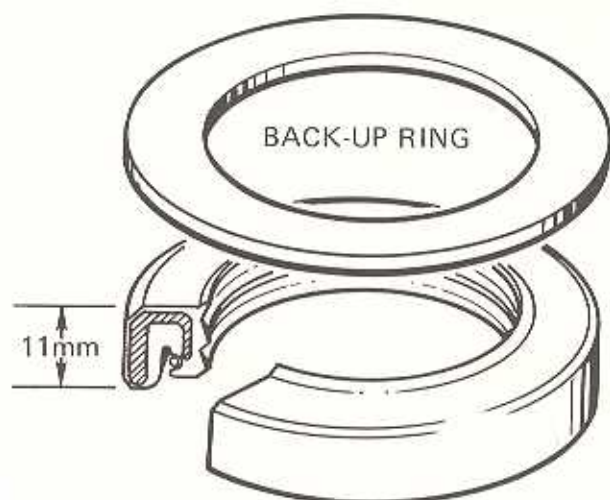
H/C 24085
P/N 91255-300-025
OLD OIL SEAL

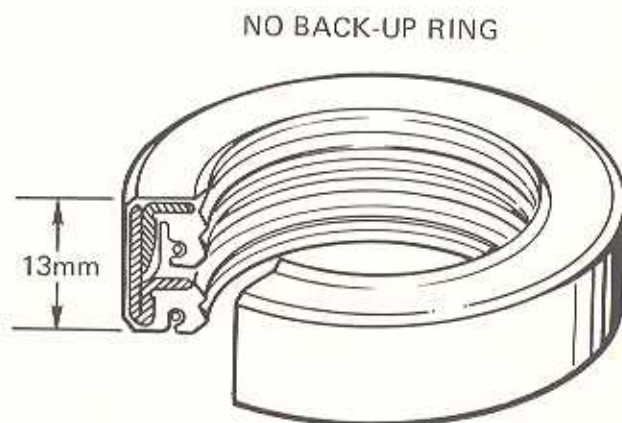
H/C 37797
P/N 91255-341-305
NEW OIL SEAL

When replacing front fork oil seals in CB-750 K1 and CB-750 K2 motorcycles, install oil seal P/N 91255-341-305. The new oil seal has a double lip.

When installing the new oil seal, discard the back-up ring which was used with the old oil seal. The back-up ring must be omitted to provide additional clearance for the new seal.

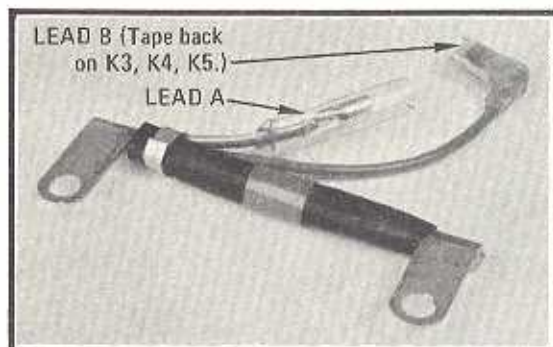
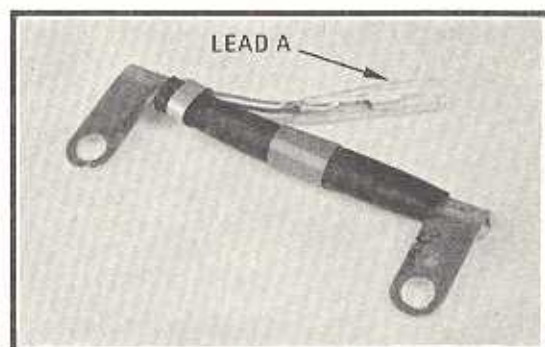
OLD BATTERY CABLE P/N 32401-300-010

BATTERY CABLE EXTRA LEAD

Factory Installation:
All CB-750, K1, K2, K3, K4.
K5 frame # 2500001 through 2503719.

During routine service or repair of K3, K4, and applicable K5 motorcycles, fold lead B to shorten its length as much as possible, and cover with electrical tape.

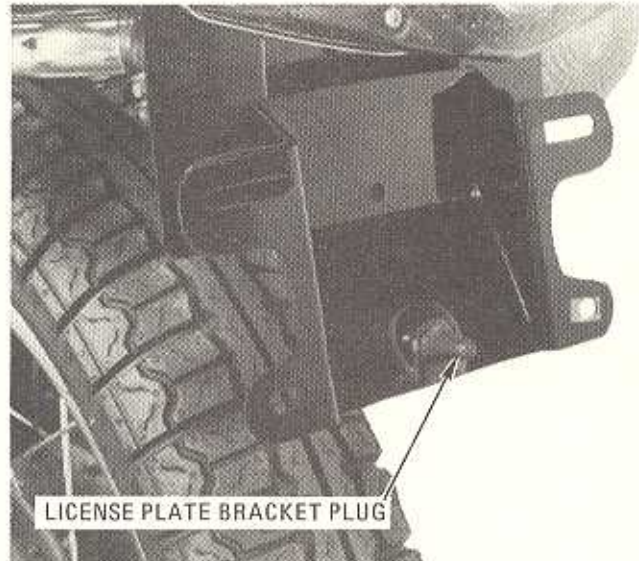
Plug for CB-550F
P/N 90899-323-610

The following CB-750F units were shipped with the extra license plate bracket plug.

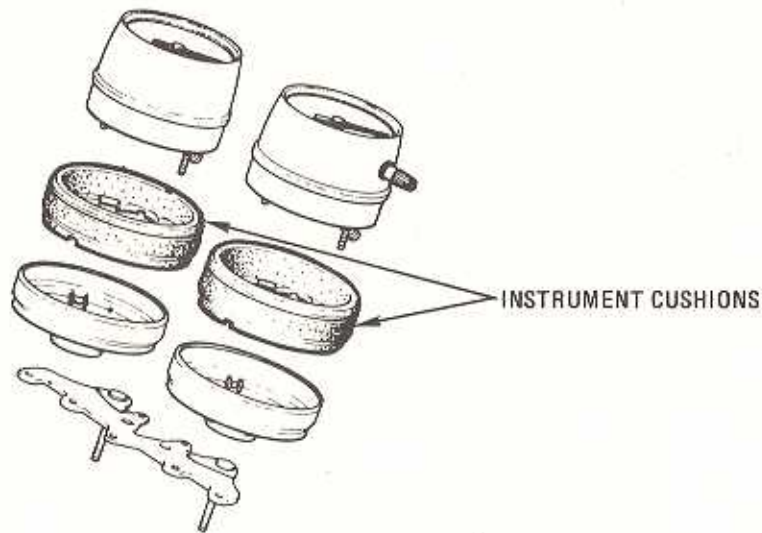
SOFT MOUNTING CUSHIONS IMPROVE INSTRUMENT ACCURACY

Instrument inaccuracy or needle fluctuation is frequently caused by vibration transmitted through the instrument mounting and does not necessarily involve any defect in the instrument itself.

Softer material is now used in instrument mounting cushions. Soft cushion material causes less vibration to be transmitted to the instruments.

Soft instrument cushions are available as replacement parts for use on earlier CB-750 models having this type of instrument assembly.
